Manhole Inspection Summary

Manhole # S710__009MH

Location Address: **1300 Bethlehem Ave.**

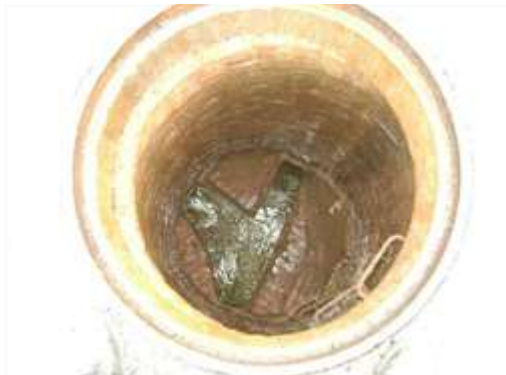
Defect 1

Offset: **1** (in.)

frame offset defect 1 in.

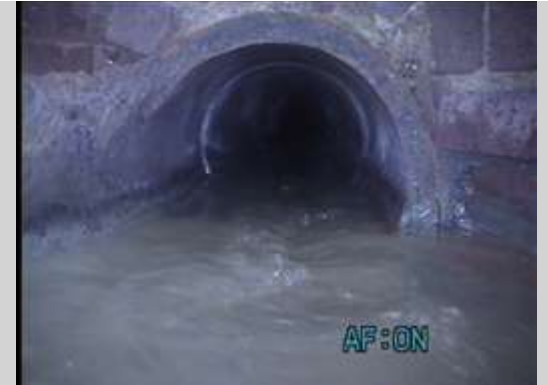
12 O'Clock Outflow

10 in. Circular Gravity Sewer
Pipe Out @ 12 O'Clock

Pipe Height: **10.8** (in.) Rod and Bar (Angled)
Pipe Material: **Clay** ☐ Pipe Lined
Invert Depth: **11.21** (ft.) Flow Characteristics: **Fast**
Deposits: ☒ None ☐ Mud ☐ Gravy ☐ Debris ☐ Grease
Silt Depth: (in.) Deposits Extent:
Infiltration: **None** Pipe Seal Cond: **Sound**

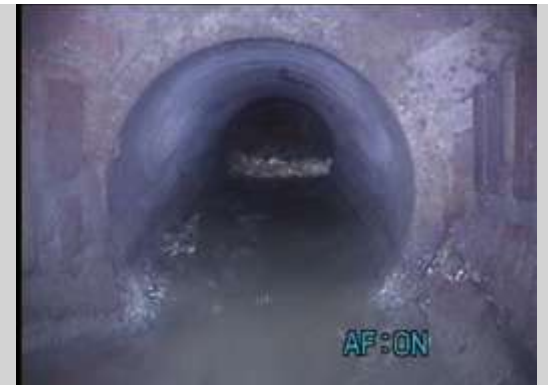
3 O'Clock Inflow

12 in. Circular Gravity Sewer
Pipe In @ 3 O'Clock

Pipe Height: **12** (in.) Rod and Bar (Angled)
Pipe Material: **Clay** ☐ Pipe Lined
Invert Depth: **11.17** (ft.) Flow Characteristics: **Fast**
Deposits: ☒ None ☐ Mud ☐ Gravy ☐ Debris ☐ Grease
Silt Depth: (in.) Deposits Extent:
Infiltration: **None** Pipe Seal Cond: **Sound**

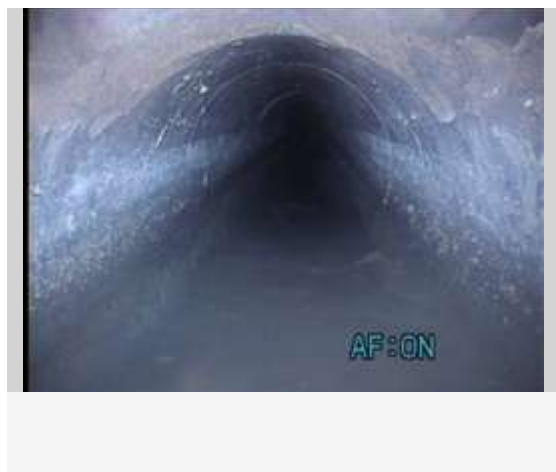
6 O'Clock Inflow

10 in. Circular Gravity Sewer
Pipe In @ 6 O'Clock

Deposits: ☐ None ☐ Mud ☒ **Sludge** ☐ Debris ☐ Grease

Silt Depth: **0.5** (in.) Deposits Extent: **Light**
